Shaft crack detected at an ammonia plant

Cracked shaft on C602 Syn Gas Compressor

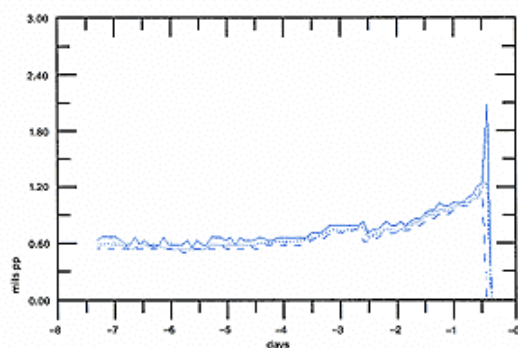
Figure 2

As the overall levels were still very low, no DDM alarms had been activated. A thorough check of all the other points on the train was, nevertheless, carried out. A small increase was noted on the vertical probe of the drive end of the input shaft on the gearbox (Figure 2). This increase was not evident on the horizontal probe (Figure 3). Further analysis of the vertical probe showed that all the vibration was occurring at 1X, and there had been a significant change in the phase angle. This change in phase angle was confirmed on the horizontal probe (Figures 4 and 5). This initial vibration data provided by the DDM gave early signs of a changing system. The ability to generate Polar Trend plots was extremely useful in explaining what appeared to be happening on this very critical machine (Figures 6 and 7). ▀

Overall vibration Trend for vertical probe on drive end of gearbox input shaft showing small increase prior to failure.

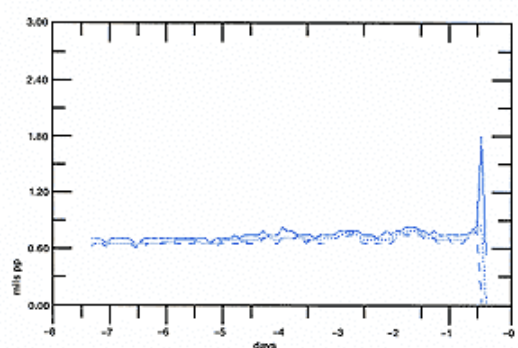
Figure 3

Overall vibration Trend for horizontal probe on drive end of gearbox input shaft was steady prior to failure.

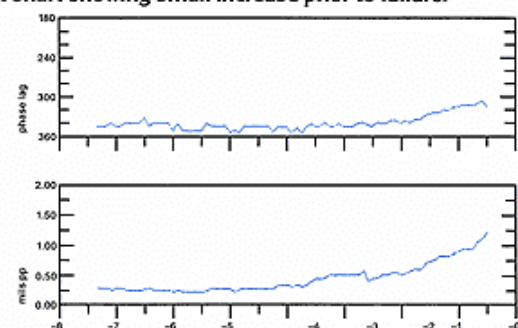
Figure 4

1 Week Trend plot of increasing 1X amplitude and changing phase angle for the vertical probe.

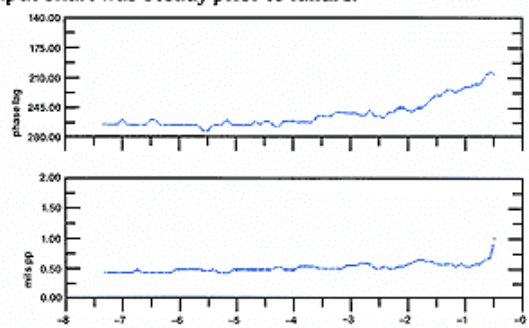
Figure 5

1 Week Trend plot increasing 1X amplitude and changing phase angle for the horizontal probe.

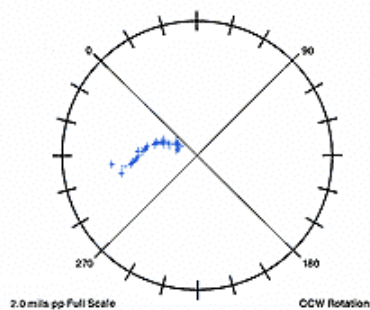
Figure 6

1X Polar Trend plot for the vertical probe.

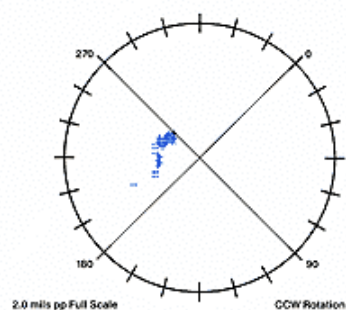
Figure 7

1X Polar Trend plot for the horizontal probe.

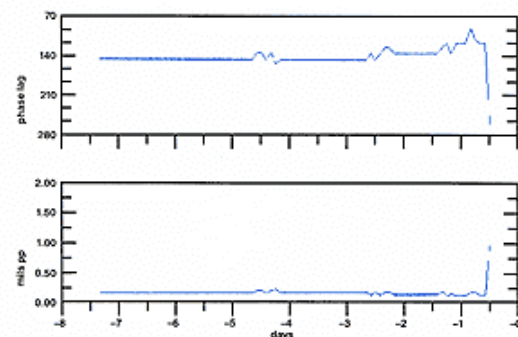
Figure 8

1 Week Trend plot of dramatic change in 2X phase angle and increase in amplitude for the vertical probe.

At around 12:30 p.m., just as the Plant Engineer and the Operations Superintendent were monitoring a slight reduction in the vibration level on the RT, there was a significant step change on the drive end of the gearbox input shaft. The vibration level suddenly increased from 1.2 to 2 mils (30.5 to 50.8 μm). A very strong 2X component of about 1 mil (25.4 μm) had suddenly appeared. Previously, there had only been a 1X component of approximately the same magnitude. The 2X phase angle was immediately checked, and it had moved from 115 to 260 degrees (Figure 8). The dramatic change in phase angle is very clearly demonstrated by the 2X Polar Trend plot (Figure 9).

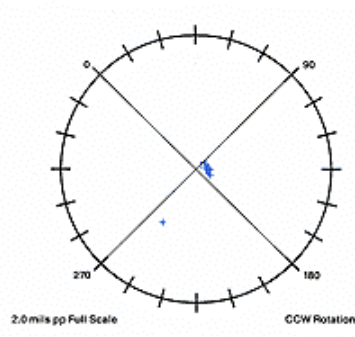
Figure 9

2X Polar Trend plot for the vertical probe.

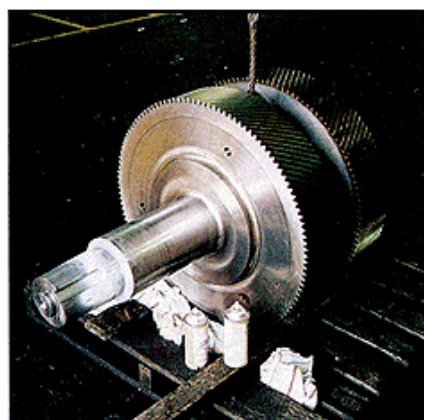
The crack appeared to have started at the keyway of the coupling taper and had propagated 180 degrees around the shaft (Figures 10-12). Subsequent ultrasonic checks showed the crack had actually penetrated 2.2 inches (55mm) into the shaft at the coupling taper, which at that point was about 5.3 inches (135mm) in diameter.

Figure 10
The bull gear component showing the location of the keyway.

Very clearly, with 18,000 HP transmitted through the gearbox, the complete failure of the input shaft was imminent. However, by successfully providing an early warning of the developing crack, the DDM allowed the Syn Gas Compressor to be safely shut down. Once the crack was found, the spare set of gears was installed, and full plant production resumed within four days. ■

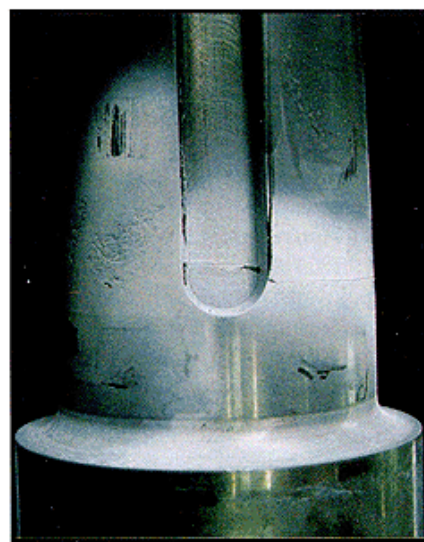
Figure 11
Detail showing the crack location in relation to the keyway.

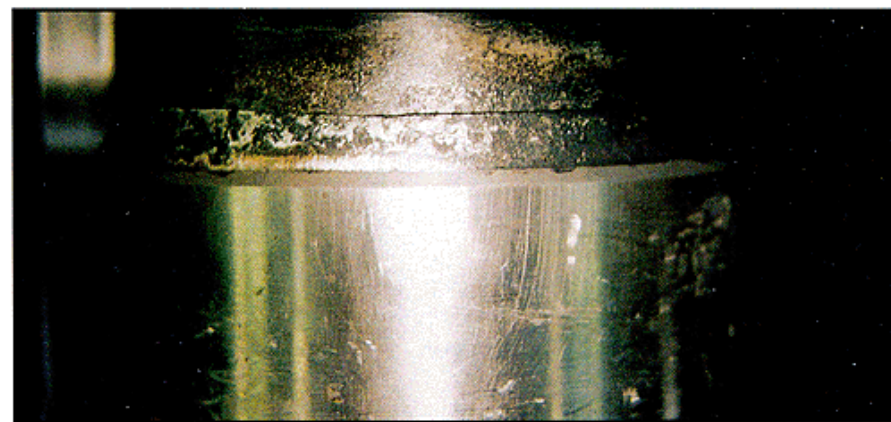
Figure 12
Detail showing fretting, corrosion and crack location.
